MURRELL'S FIELD IMPROVEMENT WORKS

EVOLUTION OF THE FIELD

Field Improvement Works Project

Improvement Works - Step by Step

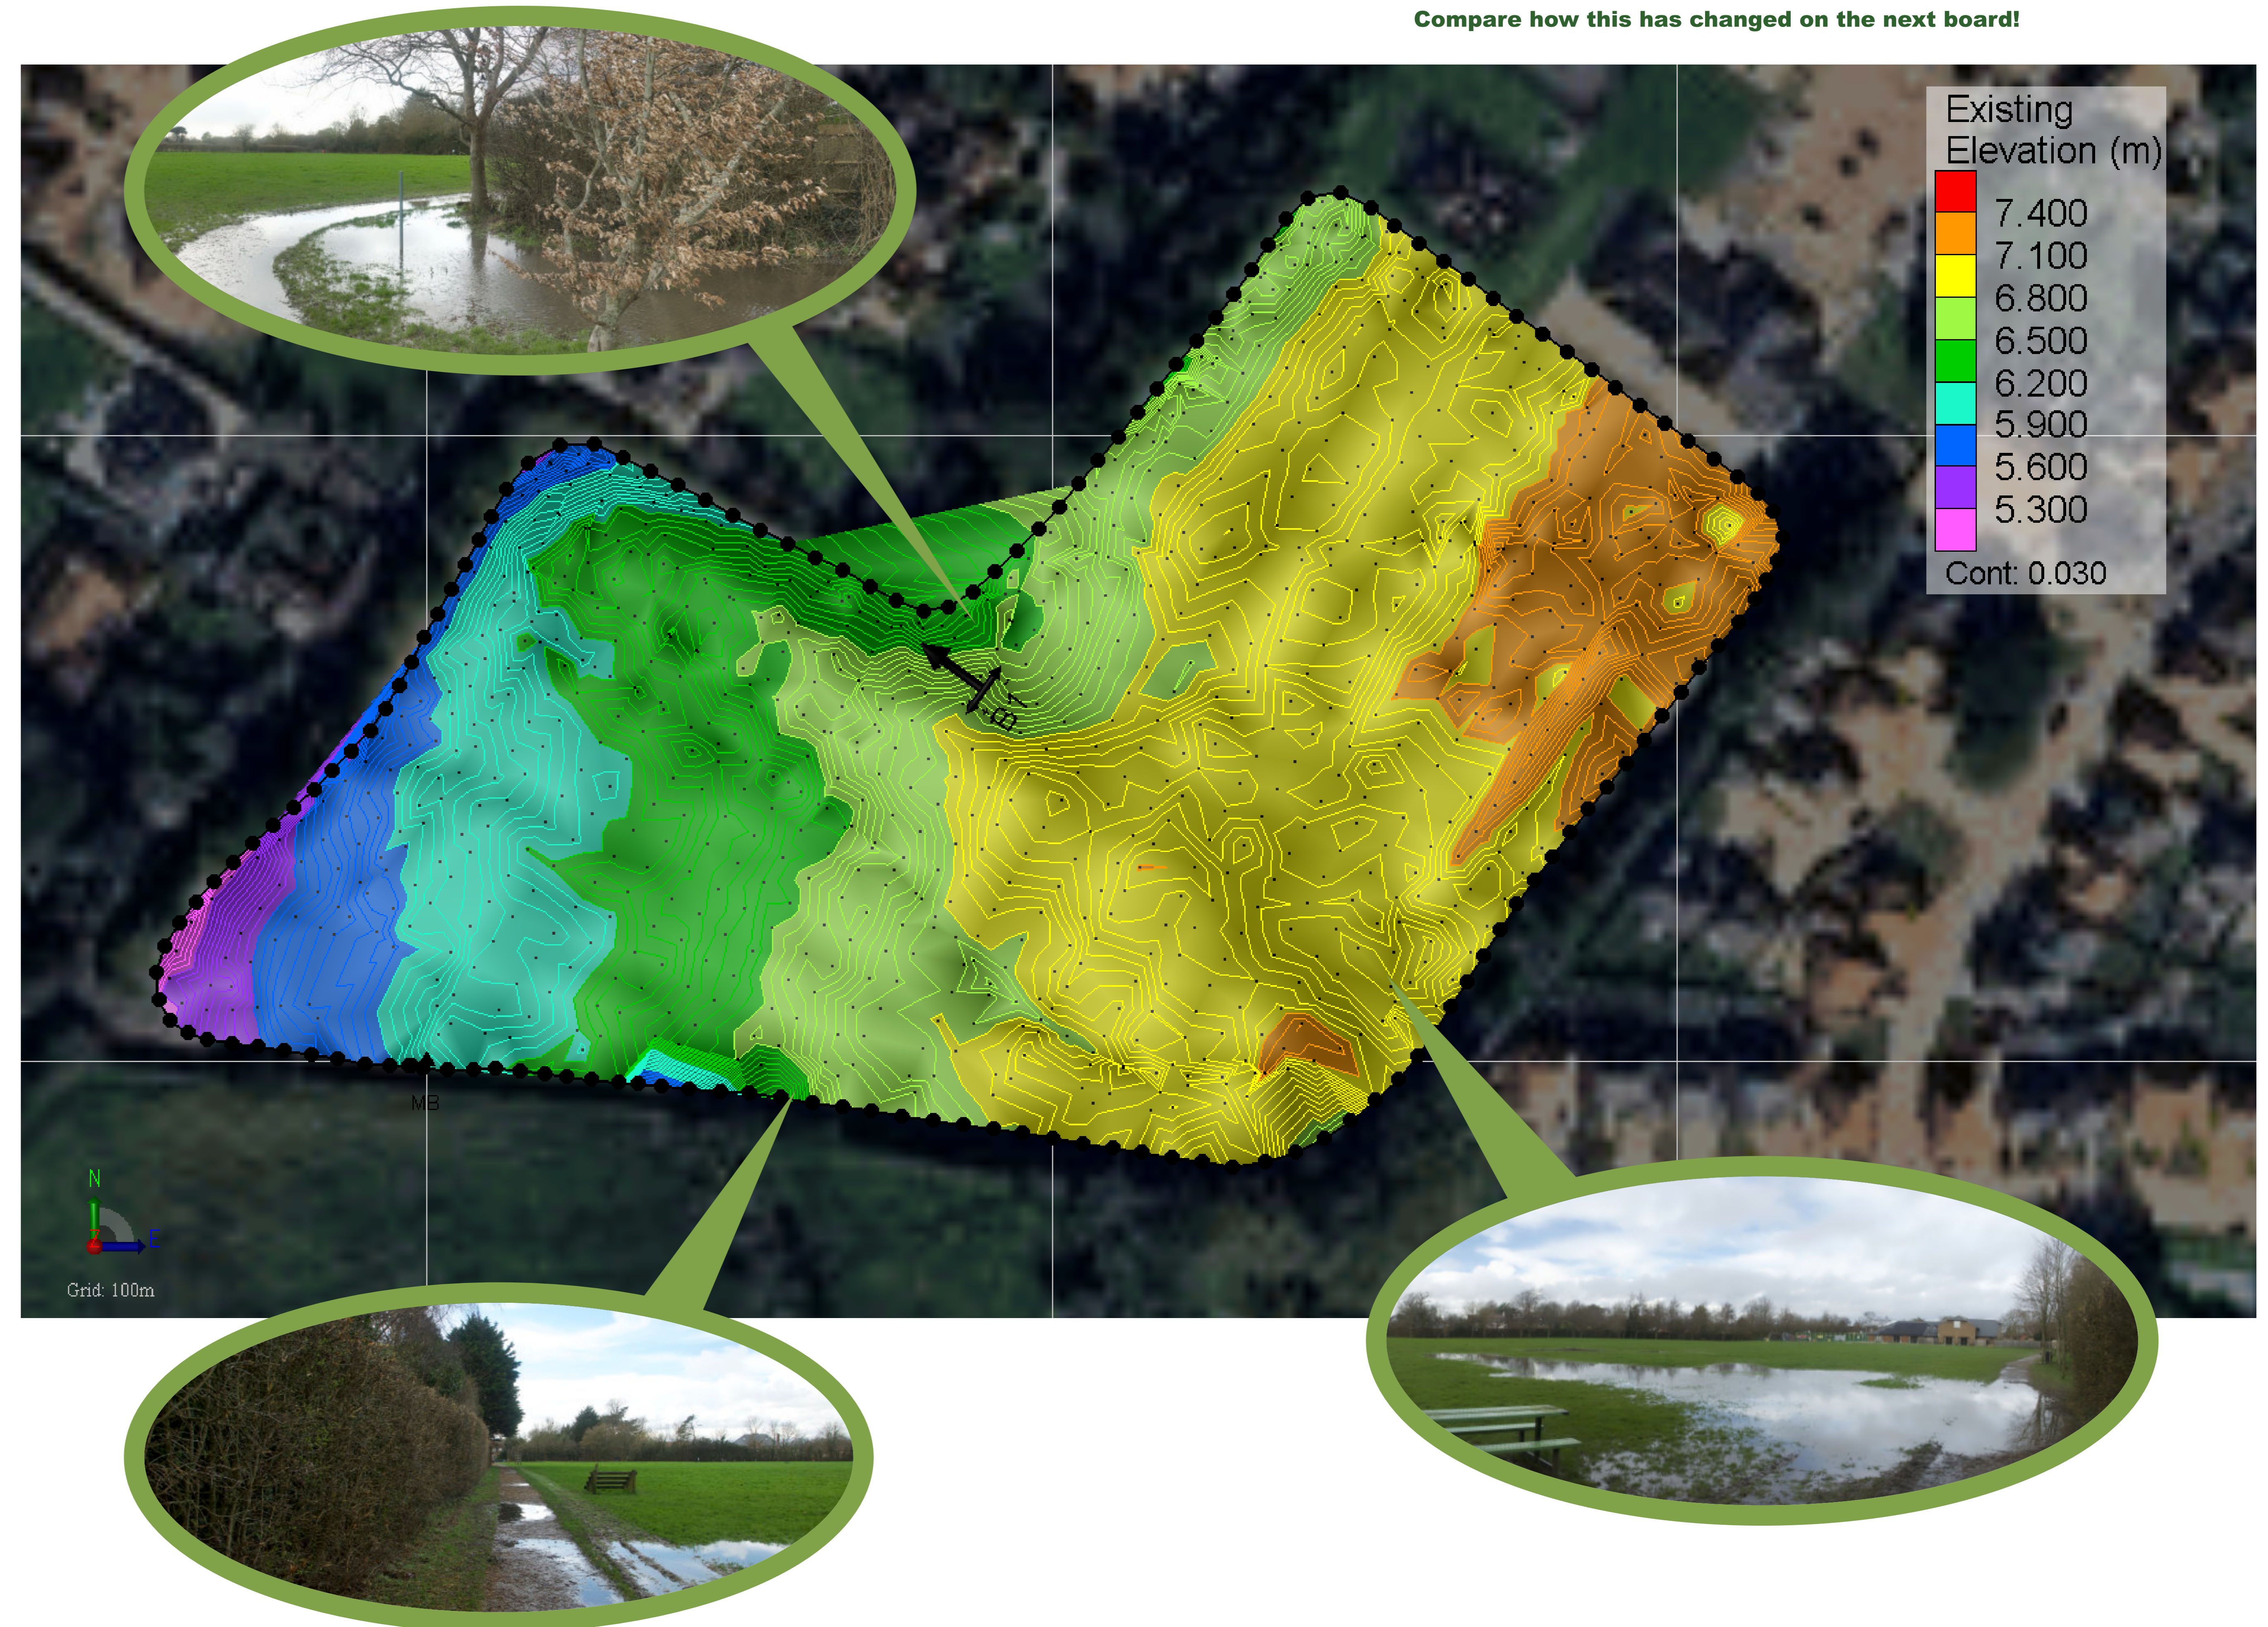
A detailed topographical survey reveals the true relief of the Field with areas of highs and lows contributing to impeded drainage and poor experience of recreation.

Compare how this has changed on the next board!

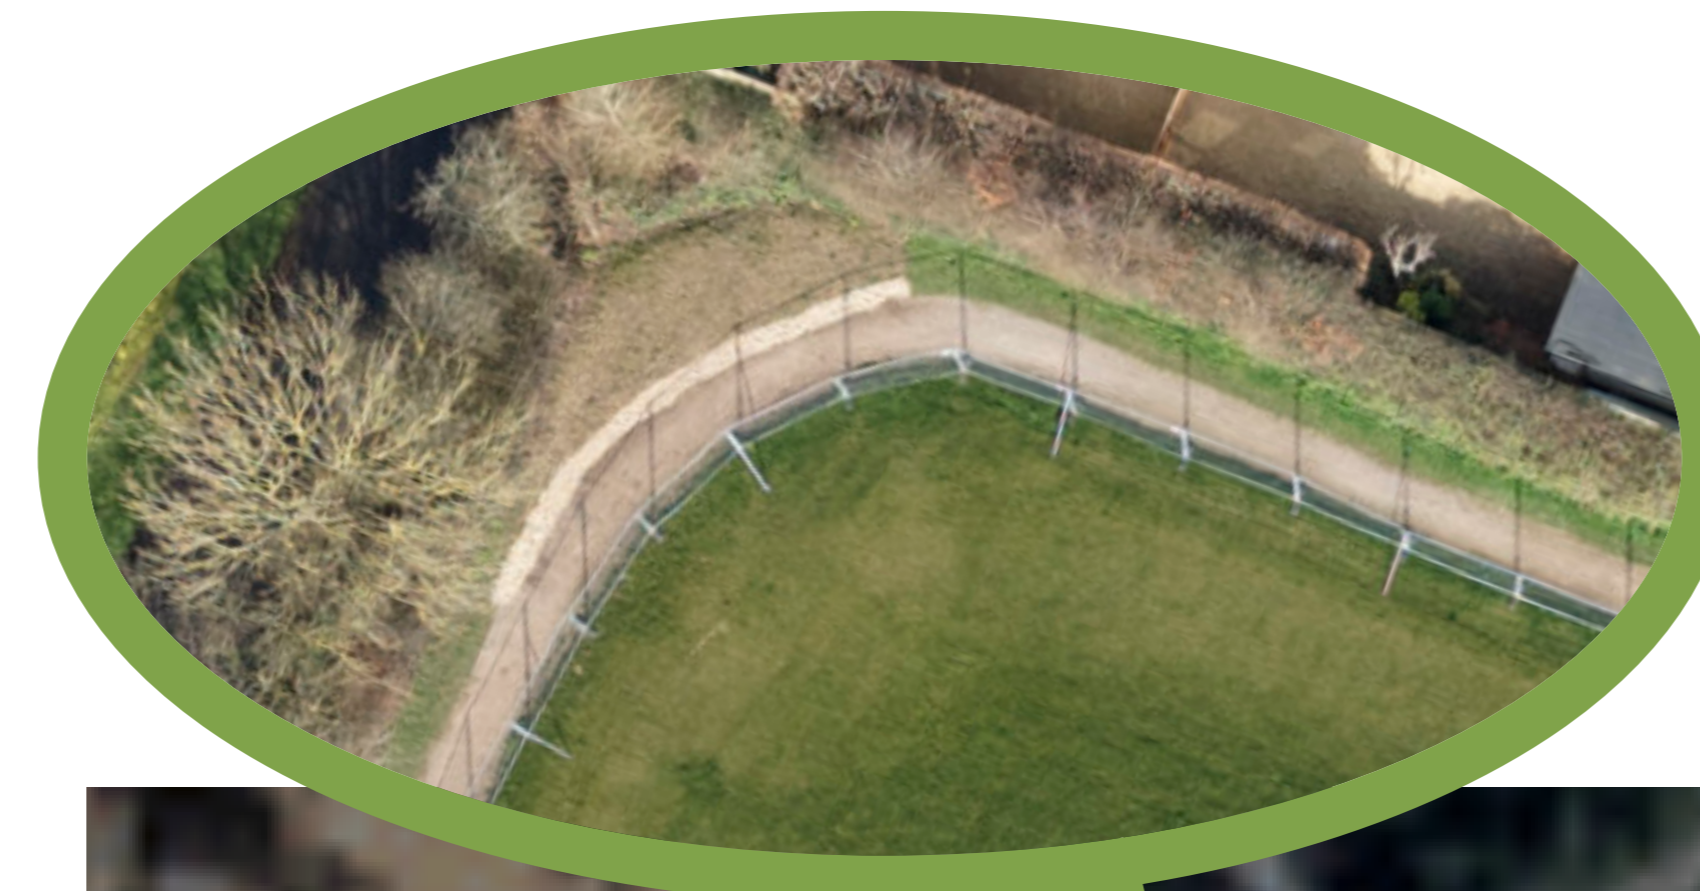
Small berm holding back runoff onto Church Lane.

Following the completion of the core scope of works, an additional gravel trench was installed along the edge of the south-west edge of the Field and a small berm formed from the spoil to further minimise runoff onto Church Lane.

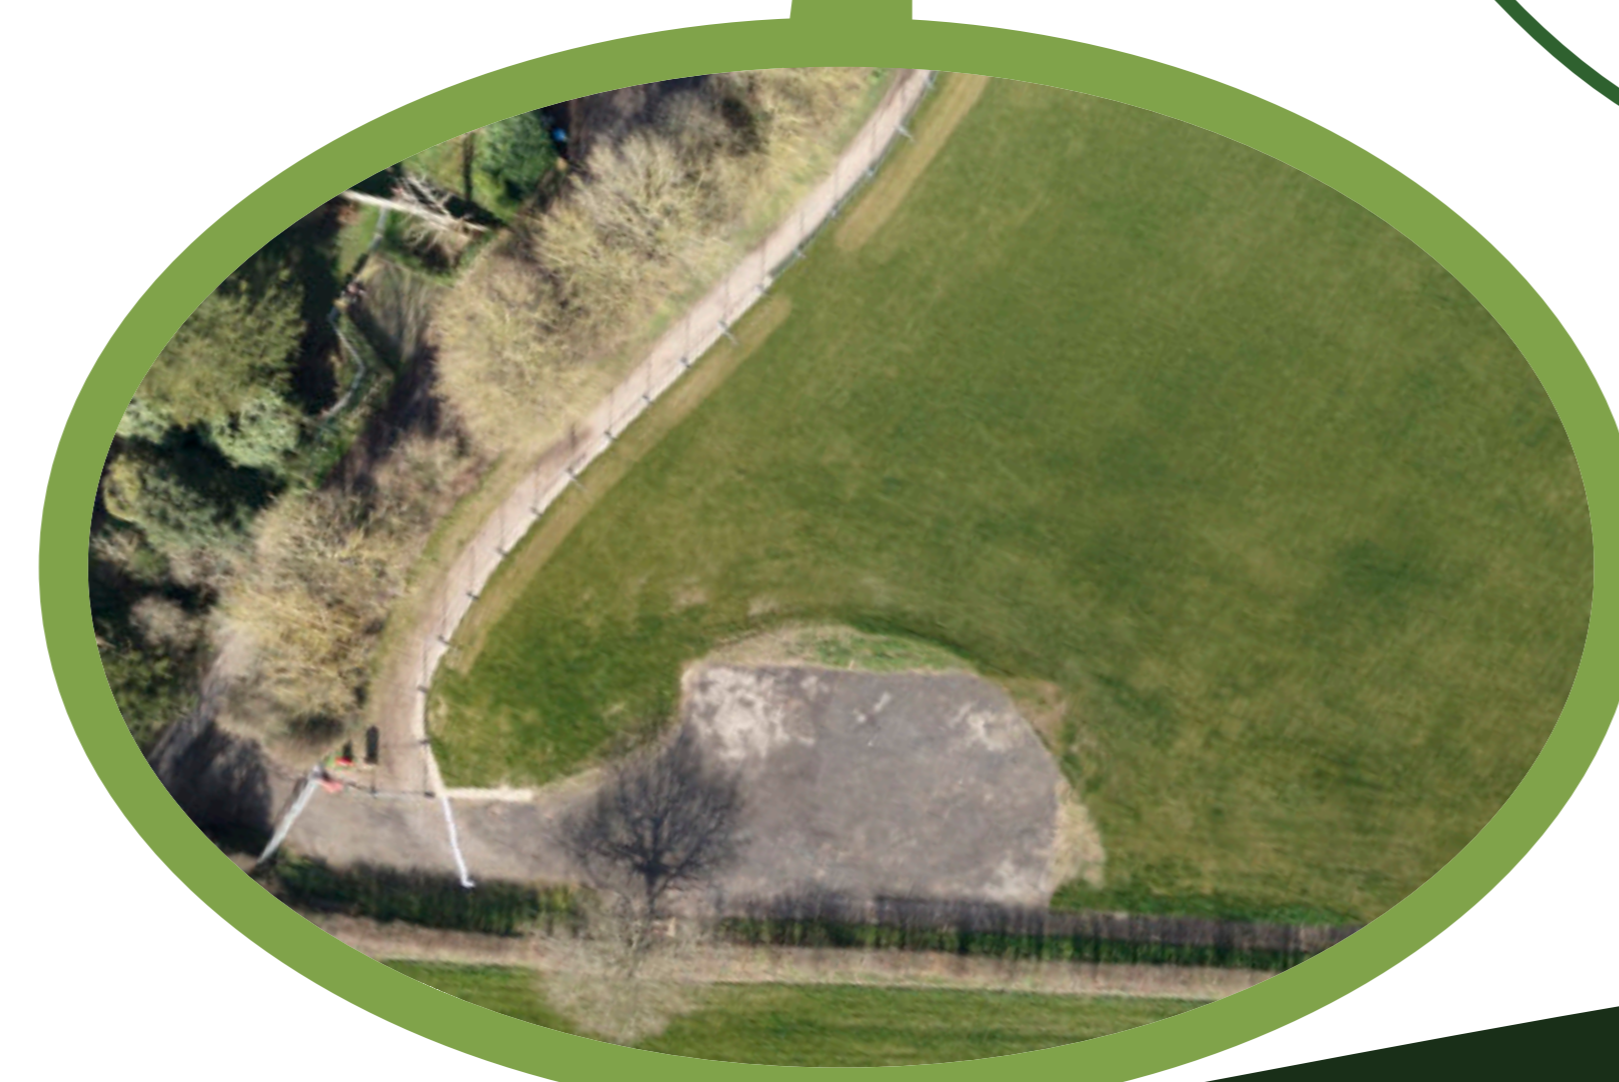
Additional gravel trench along the edge of the footpath.

- Step 1** The additional work commenced in mid-November.
- Step 2** Narrow trenches were dug along the edge of the footpath on the Church Lane side. They were then filled with pea gravel to further facilitate capturing runoff from the Field.
- Step 3** The spoil from trenches was used to create a low berm on the outer edge of the path where heavy runoff onto Church Lane had previously been observed.
- Step 4** The works were completed by the 24th of November and the western section of the footpath was reopened to the public.
- Step 5** The Council is considering some further interventions to the western section of the footpath with an aim to prevent water pooling on the surface, minimise surface flow along the footpath that causes its erosion and to create additional storage capacity. Options have been discussed and estimates are being sought from the contractor.

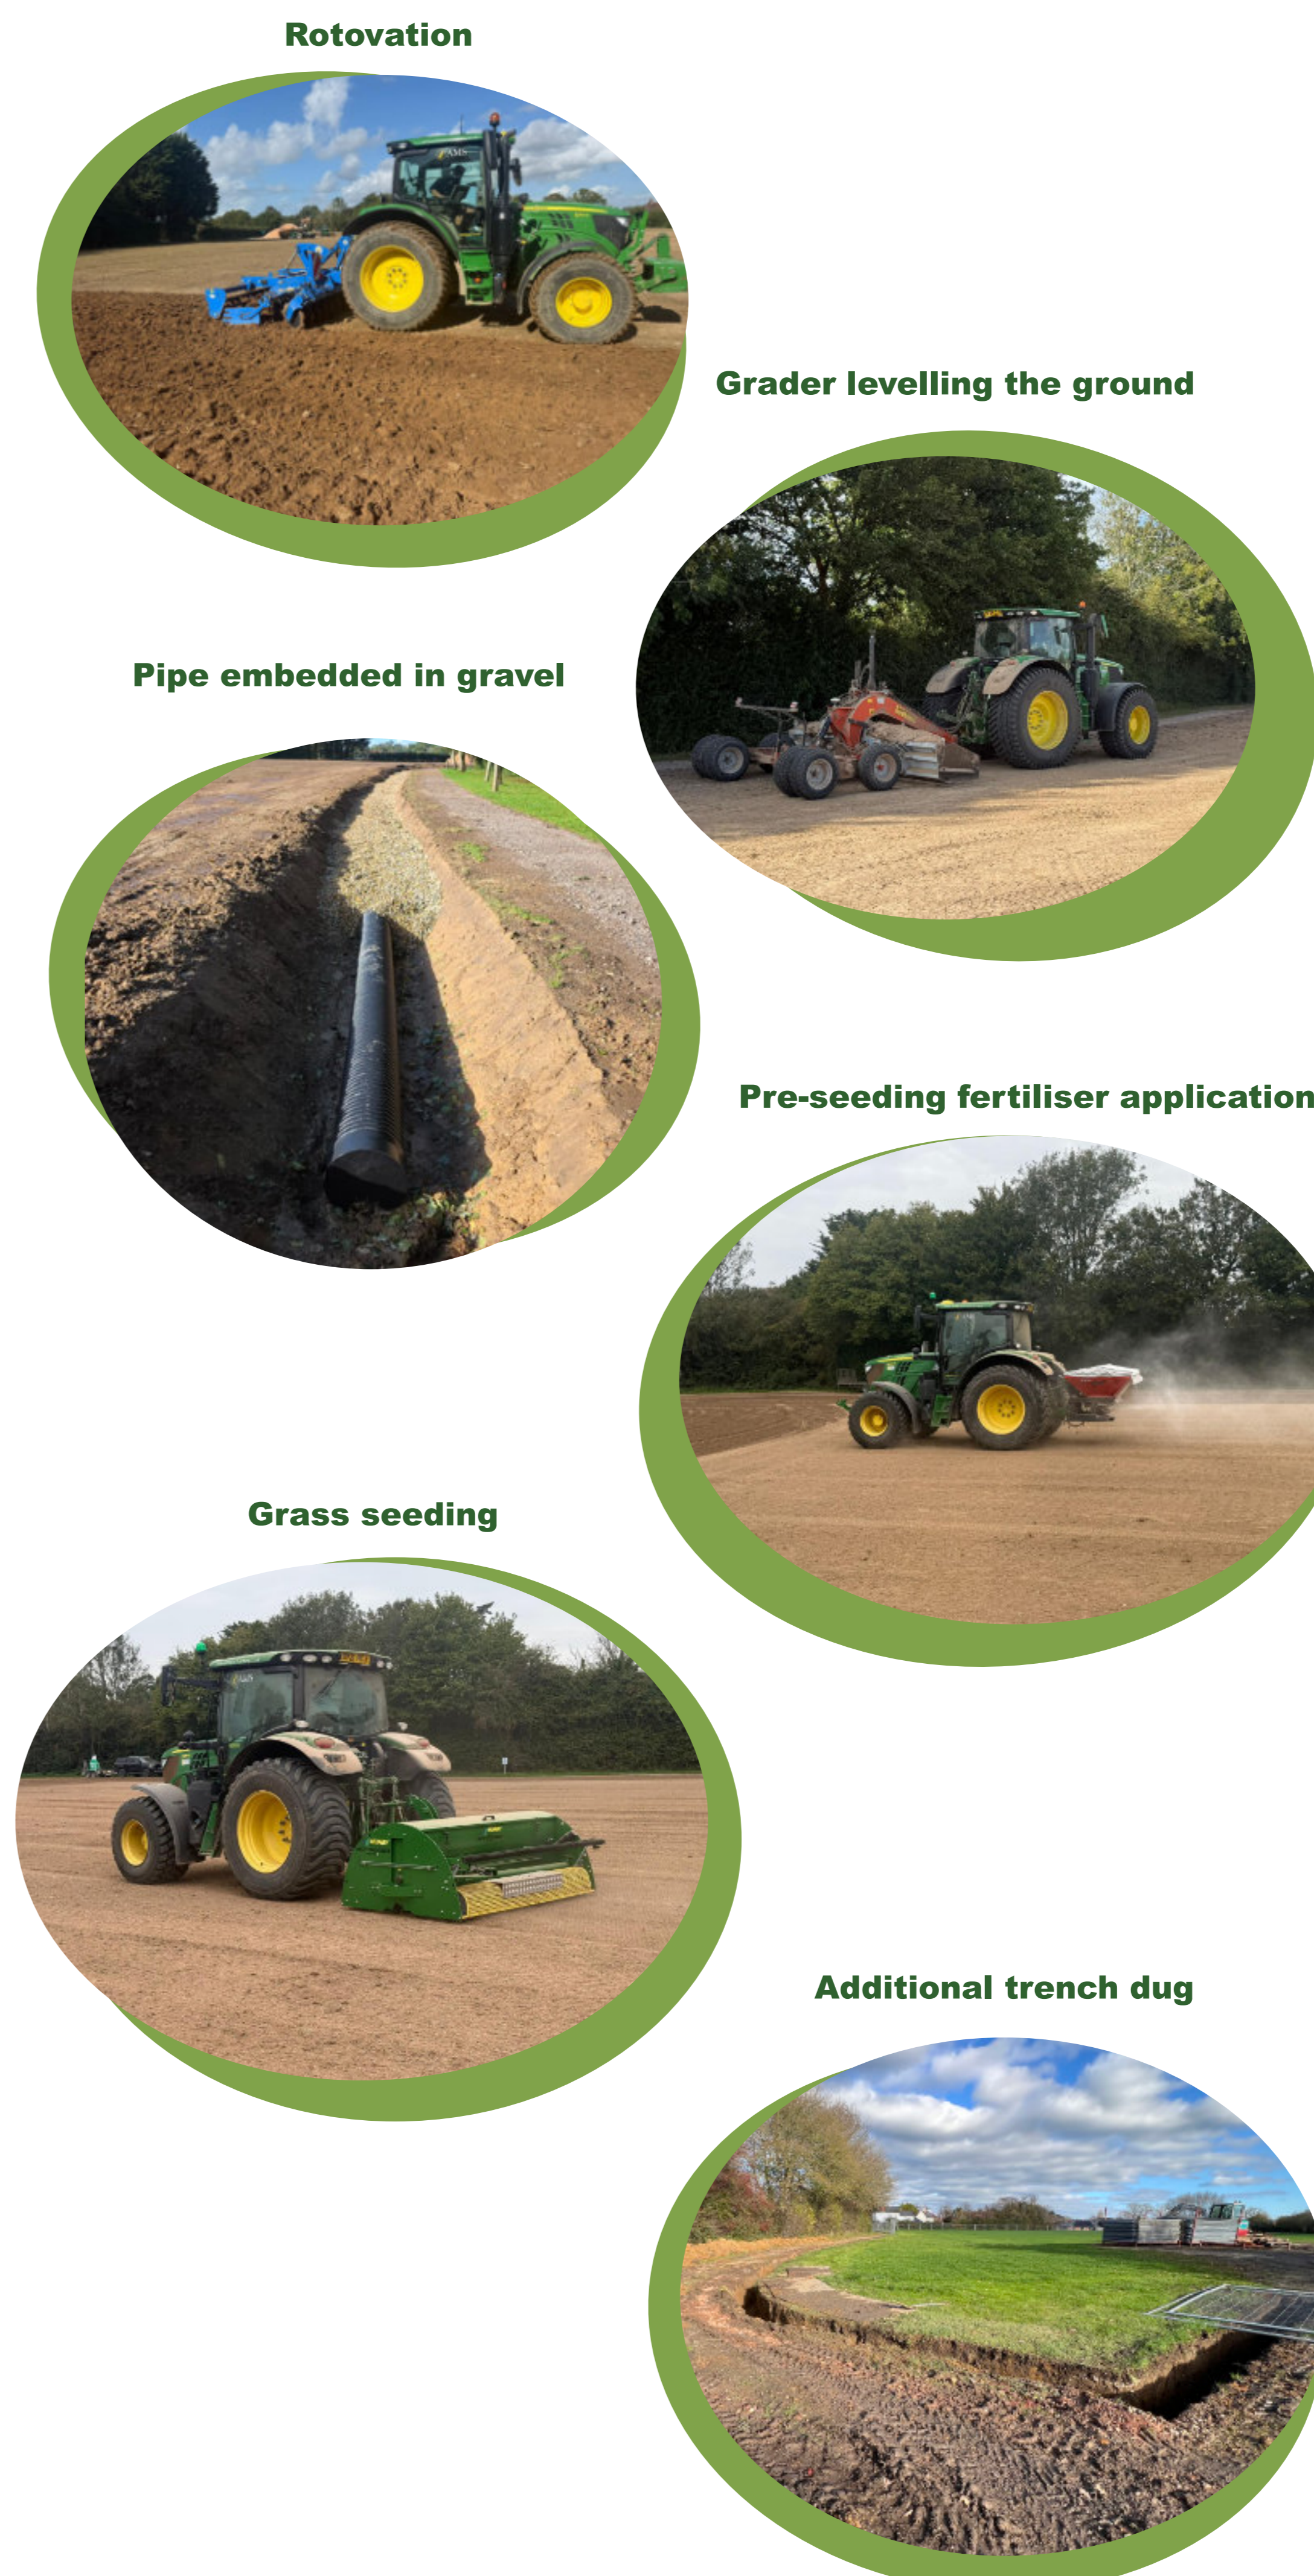
Mechanical Power in Action

Grader - A four metre blade which is pulled behind the tractor. The operation is controlled by GPS which moves the blade up or down automatically to achieve the new levels. It cuts the highs and fills the lows to create a balanced cut-and-fill formation

Subsoiler – A machine that breaks up compacted layers of soil deep below the surface to improve drainage and root growth. It has heavy, vertical tines called legs attached to the frame that extend down into the soil to break up the compacted layers.

Rotary rake - a machine that uses rotating arms with tines to lift and move hay or to prepare a seed bed for sowing.

Power harrow – A tool that finely breaks up the top layer of soil, creating an even surface for sowing grass or wildflower seed.

Stone burier – Equipment that buries stones and debris below the soil surface, creating a clean top layer for planting or turfing.
